**Bundesstelle für Seeunfalluntersuchung**  
**Federal Bureau of Maritime Casualty Investigation**  
Federal Higher Authority subordinated to the Ministry of Transport,  
Building and Urban Development

Summary  
Investigation Report 20/09

**Collision on the Kiel Canal (NOK)**  
**between HANSE VISION and BIRKA EXPRESS**  
**on 12 January 2009 at 1424**

1 March 2010

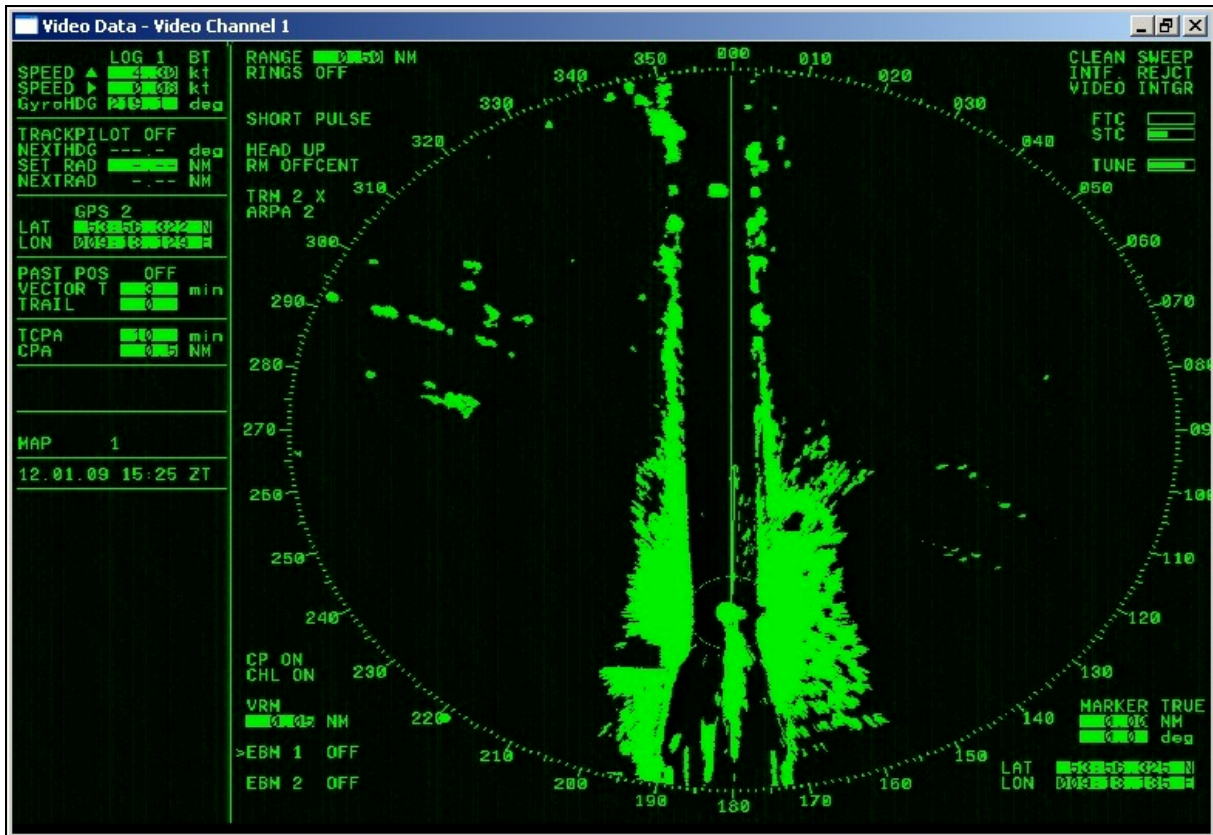
Figure 18: Radar image of the BIRKA EXPRESS at 1425

The radar images confirm the manner in which the AIS records of the VTS represent the course of the accident.
