Runway Excursion during Touch-and-go on Instructional Flight at Lahti-Vesivehmaa Aerodrome on February 7, 2021

L2021-01

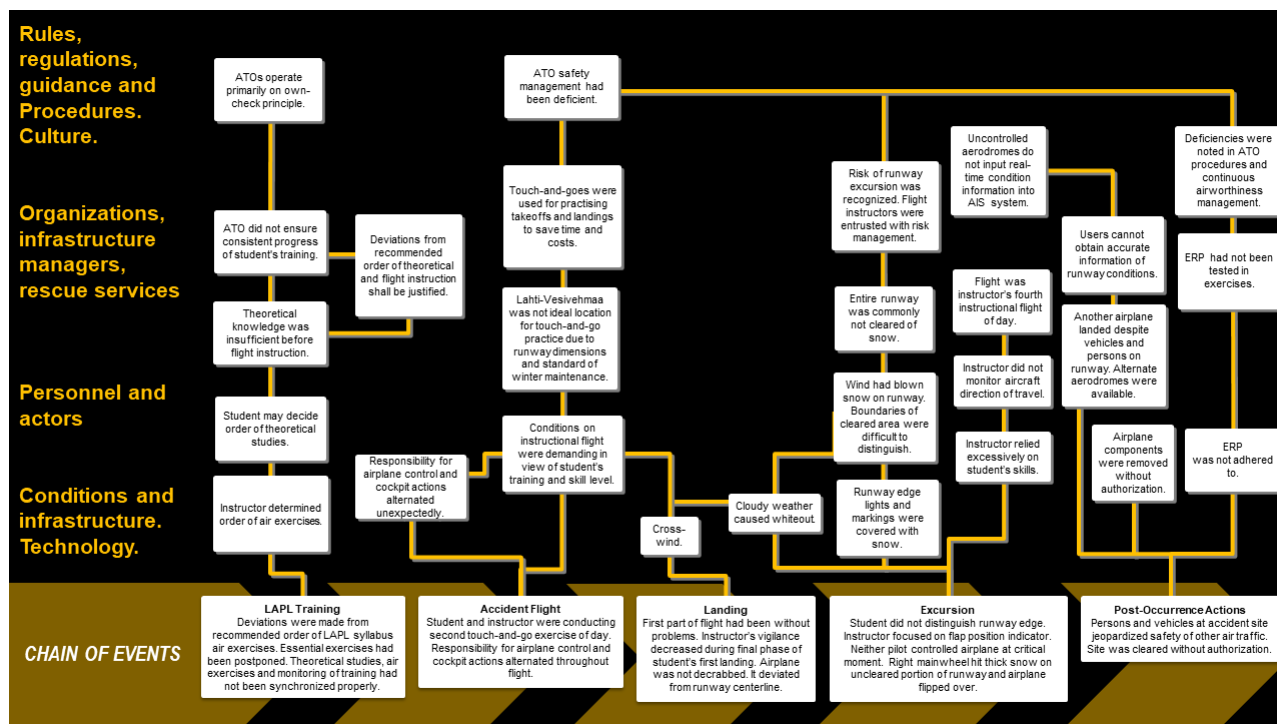
A SIAF-developed format of the AcciMap approach⁵² was used to support the analysis of the occurrence. The following text is arranged in accordance with an AcciMap diagram created during the investigation and shown in Figure 11. The occurrence is depicted as a chain of events along the bottom of the diagram. Contributing factors at various levels can be examined by moving up and down the diagram.

Figure 11. AcciMap diagram, investigation L2021-01. (Photo: SIAF)
