# Grounding of M/V Timca (NL) off Rauma on 16 February 2021

M2021-01

Investigation ID: M2021-01  
Investigation report 1/2022  
ISBN: 978-951-836-614-3(PDF)

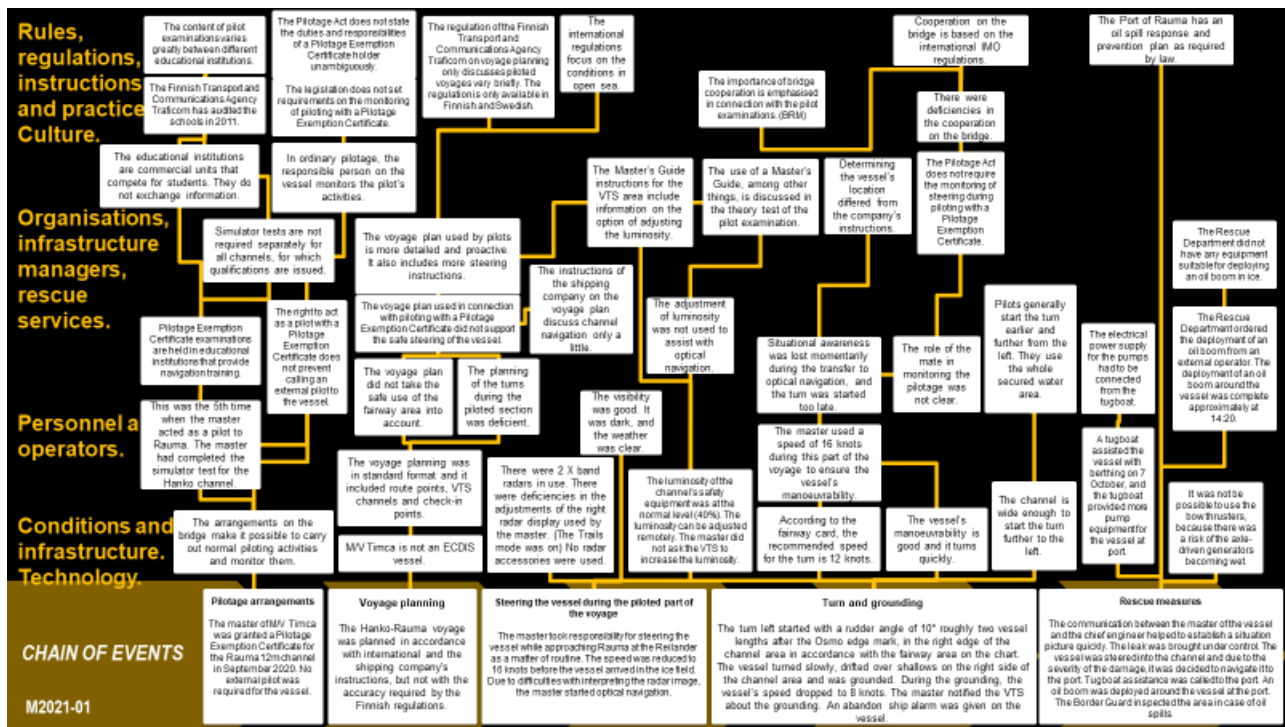
The Accimap method further developed by the Safety Investigation Authority has been used in the event analysis. The structure of the analysis text is based on the Accimap diagram drawn up during the investigation. The accident is described as a chain of events at the bottom of the diagram. Factors revealed in the background of the chain of events are discussed in the diagram at different levels of analysis.

Picture 16. Accimap diagram (Image: SIA)
