# Amateur-built Aircraft Accident at Hyvinkää Aerodrome on September 27, 2021

L2021-03

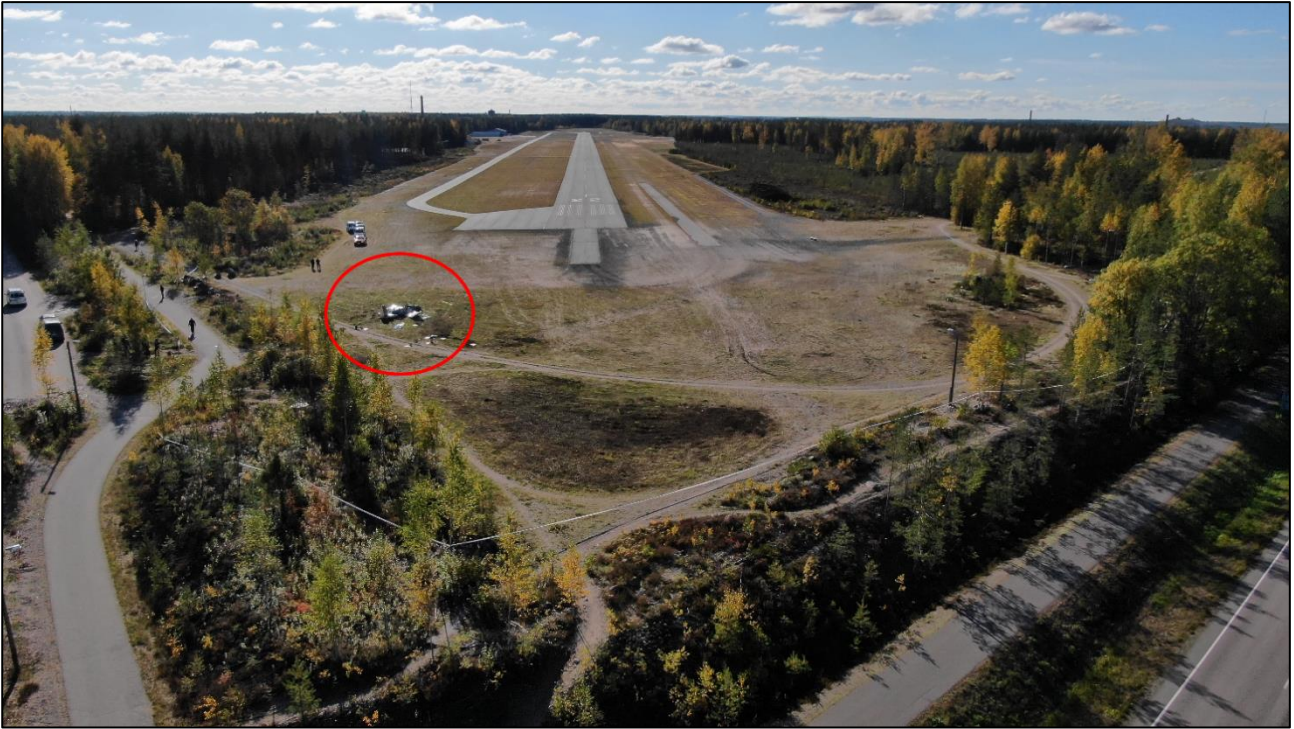
**Figure 1.** The accident scene as seen from final to runway 22 with the accident site circled in red. (Photo: Eastern Uusimaa Police Department, edited by SIAF)

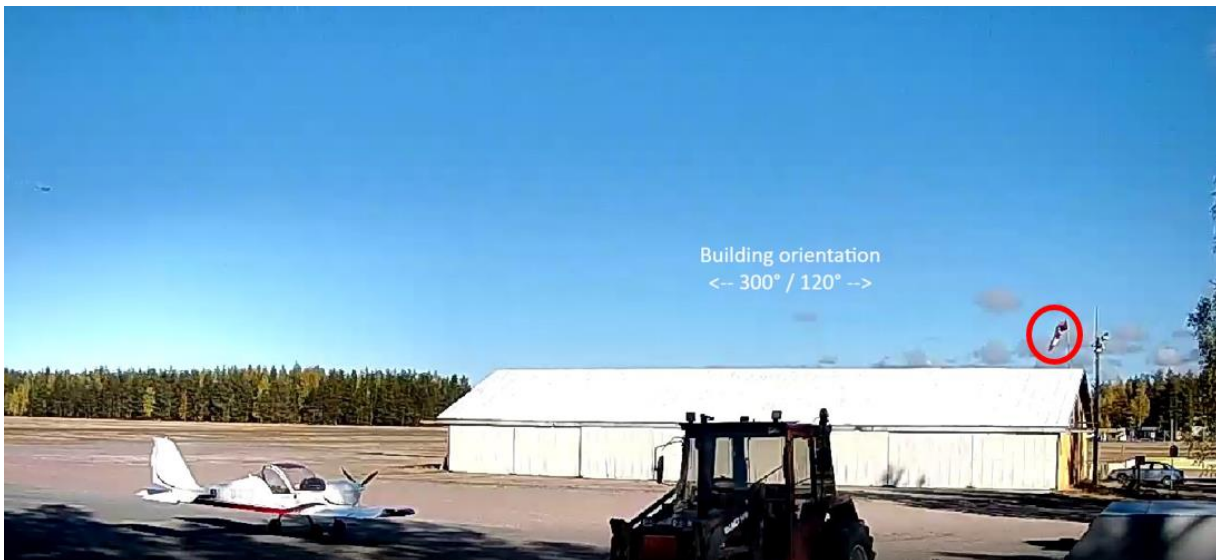
Weather on the day of the accident was clear and sunny. The weather observation facility at Helsinki-Vantaa airport<sup>19</sup> located 37 km from Hyvinkää aerodrome reported winds from 110° variable between 080° and 170° at 3 m/s. Temperature was 12 °C and dew point was 8 °C. Atmospheric pressure was 1,031 hPa. Visibility was over 10 km with few clouds at approximately 550 m. Hyvinkää aerodrome has no automatic weather observation facility. Aerodrome surveillance video recording of the windsock at the time of the accident was examined. Imagery shows that wind was from 120° to 130° at 2 to 3 m/s, and the motion of the windsock suggested neither gusting nor variations in wind direction.

**Figure 8.** The windsock at the time of the accident, circled in red. (Photo: Hyvinkää aerodrome surveillance video recording, edited by SIAF)

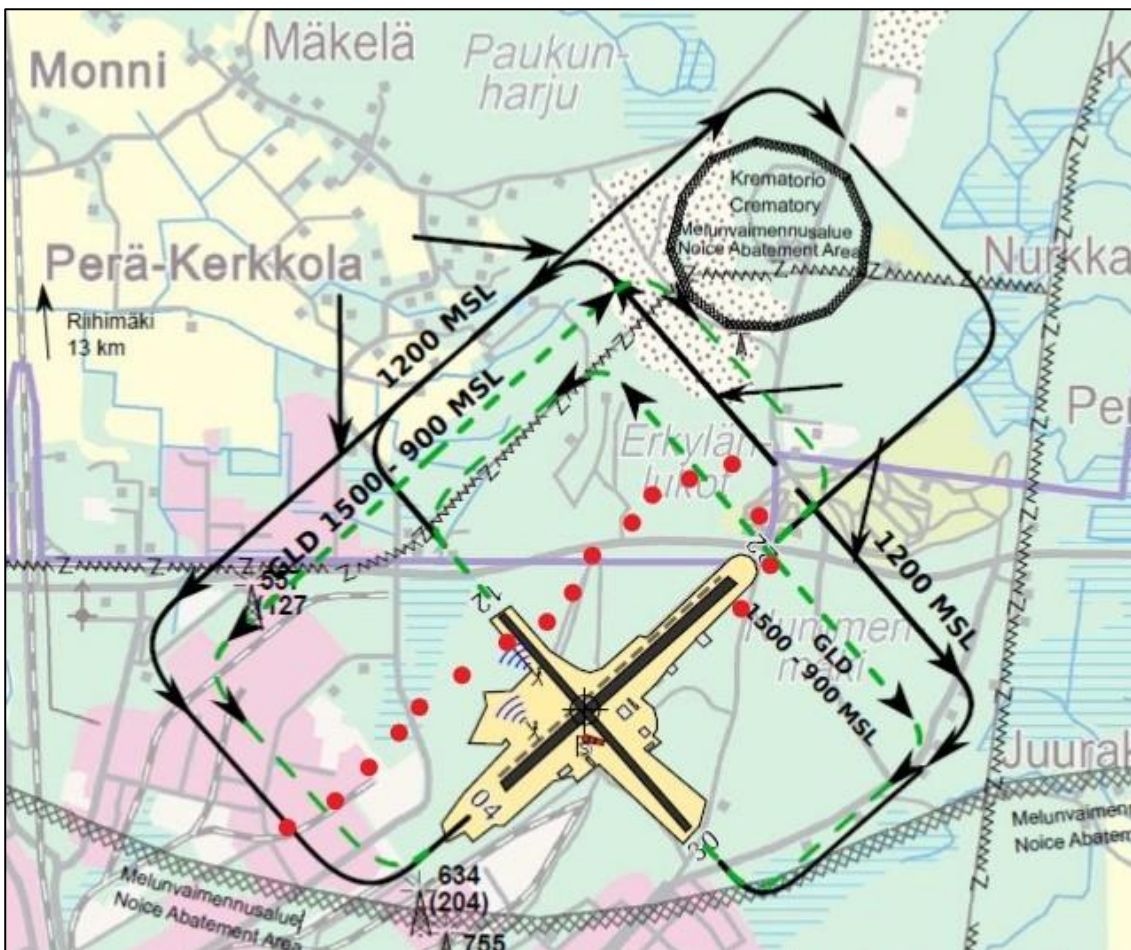
The airplane joined the traffic circuit at the beginning of right downwind at 1238 h, at 1,000 ft AMSL and at approximately 100 kt<sup>22</sup> groundspeed. Groundspeed reduced on the downwind leg to approximately 90 kt and altitude began to decrease. The airplane initiated the turn towards the threshold at 600 m AMSL at approximately 80 kt groundspeed. Recorded data did not permit the detailed examination of the flight on the base leg. During the turn, the airplane descended to approximately 500 ft AMSL, and recorded data suggested a possible further speed reduction during the turn.

The airplane's trajectory on the unofficial Hyvinkää aerodrome landing chart<sup>23</sup> is shown in figure 9. The red dots indicate the airplane's ground track in the traffic circuit.

**Figure 9.** The airplane's track on the unofficial landing chart. The black lines represent the traffic circuits. The red dots are SSR targets. (Photo: Tom Arppe, edited by SIAF)

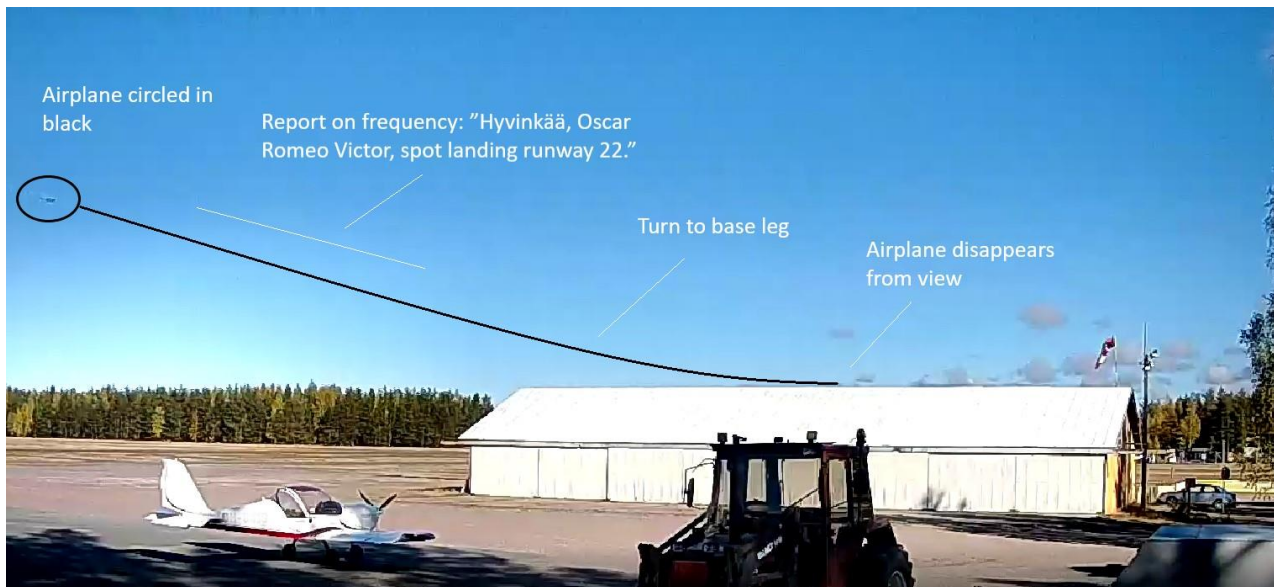
**Figure 10.** The airplane's flight path derived from video recording. (Photo: Hyvinkää aerodrome surveillance video recording, edited by SIAF)

The aerodrome surveillance video captured the airplane at the end of right downwind for runway 22 and during the base turn. Radio communications on the aerodrome frequency were captured on the recording. At 1235 h, the pilot receiving instruction reported that OH-XRV was approaching the aerodrome and estimated joining the traffic circuit in 2 minutes. At 1237 h, he reported an intention to carry out a simulated forced landing with power<sup>24</sup> on runway 22. At 1238, he reported downwind for runway 22 and advised that he would commence the simulated forced landing. At 1239 h, the pilot of the holding airplane reported the accident on the frequency. Video footage shows the accident airplane in rapid descent.

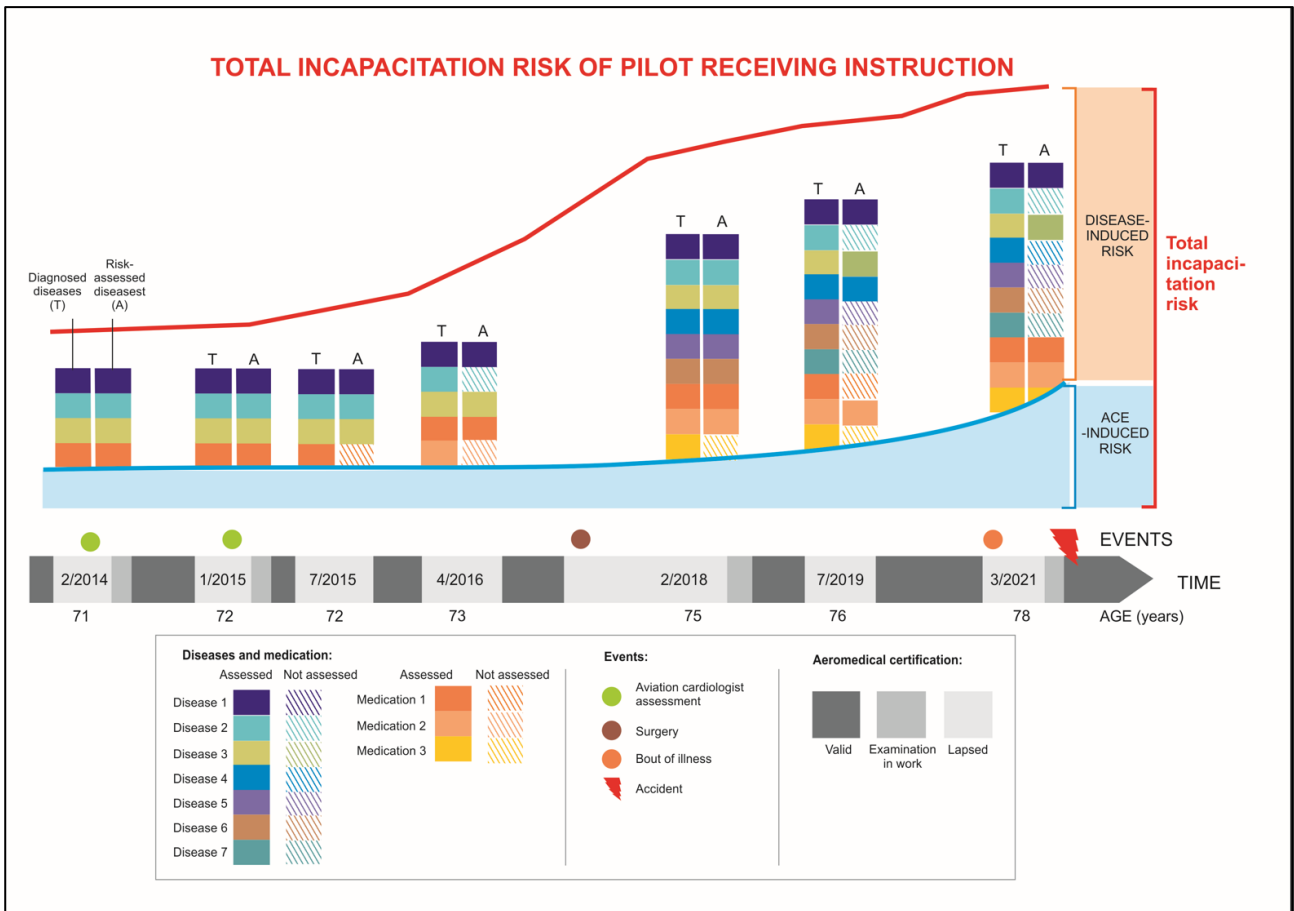
This examination commenced in March 2021, by which time the pilot's medical certificate had been lapsed for approximately 10 months. A cardiologist's evaluation had begun in January 2021. During the evaluation, the anticoagulant was changed to a type that did not require regular laboratory monitoring. This change necessitated a waiting period of three months and a new stress ergometry test. It became necessary to conduct the test in a hospital because the heart rate could not be raised sufficiently. No indication of significant oxygen deprivation in the heart muscle was found in the hospital examination, and the stress ergometry test produced findings that were identical with those obtained in 2019. On July 30, 2021, the pilot was granted an LAPL aeromedical certificate valid until March 18, 2022. The validity of the certificate was limited to 12 months from the commencement of the examination, and the pilot was required to produce a report of a cardiologist's evaluation in the next examination. On August 19, 2021, the licensing authority specified that the pilot should also produce the results of a stress ergometry test and of an ultrasound of the heart in the next examination.

**Figure 11.** Timeline showing diseases, medications and development of incapacitation<sup>31</sup> risk, based on the results of aeromedical examinations. (Photo: SIAF)

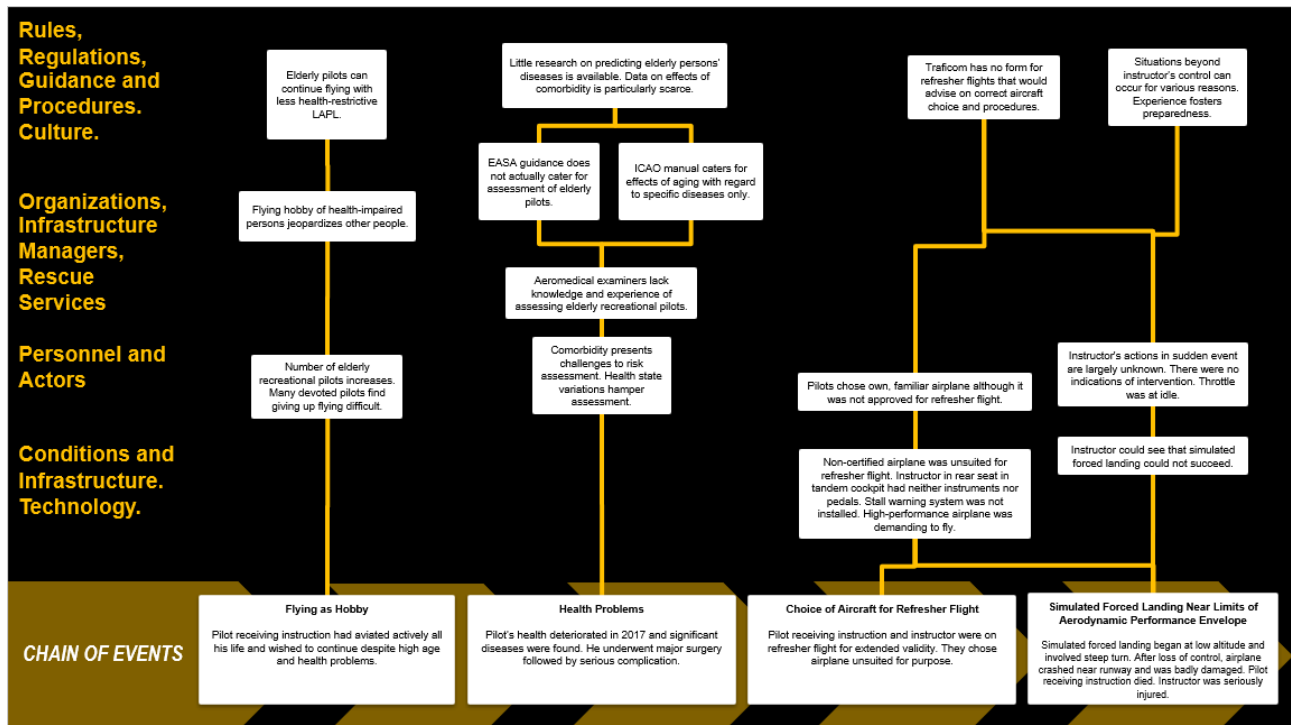
A SIAF-developed format of the AcciMap approach<sup>54</sup> was used to support the analysis of the occurrence. The following text is arranged in accordance with an AcciMap diagram created during the investigation and shown below. The occurrence is depicted as a chain of events along the bottom of the diagram. Contributing factors at various levels can be examined by moving up and down the diagram.

Figure 18. AcciMap diagram, investigation L2021-03. (Photo: SIAF)
