Corporate Aircraft Collision with Lamp Post during Warm-up Run at Kemi-Tornio Airport on December 5, 2021

L2021-05

Investigation designator: L2021-05
Investigation report 9/2022
ISBN: 978-951-836-640-2 (PDF)

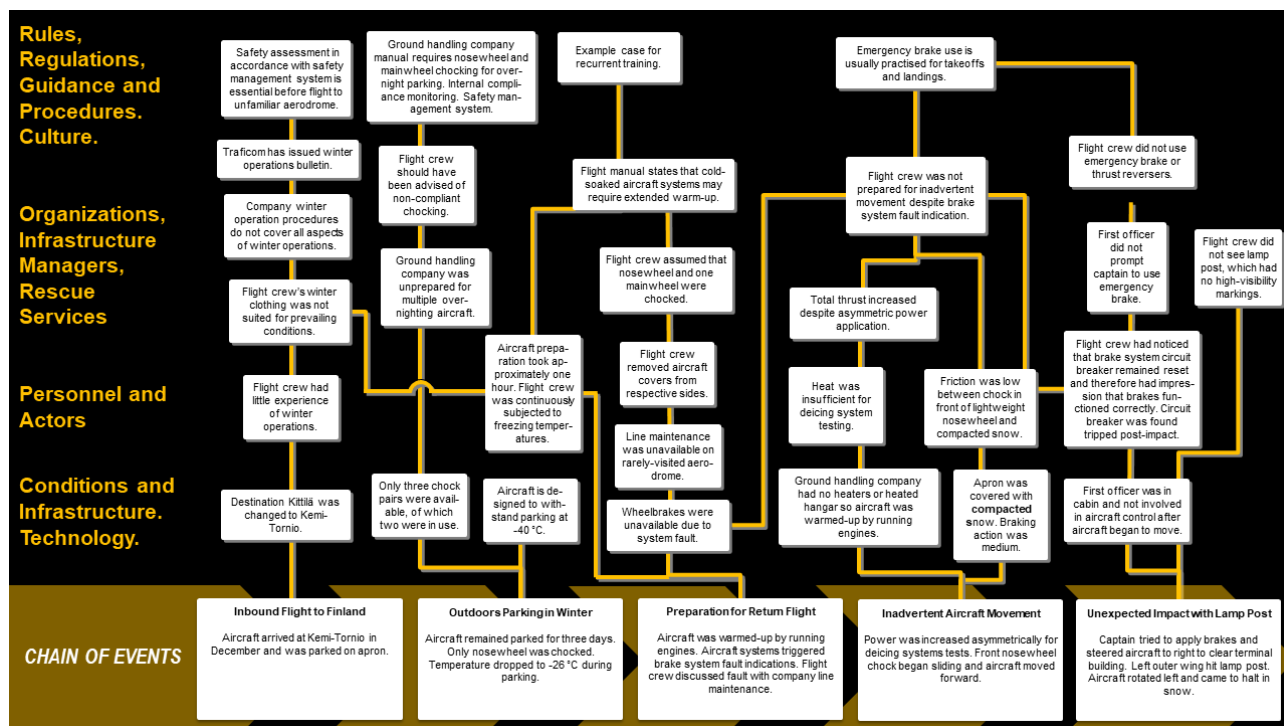
Figure 11 AcciMap diagram, investigation L2021-05. (Photo: SIAF)

A SIAF-developed format of the AcciMap approach²⁸ was used to support the analysis of the occurrence. The following text is arranged in accordance with an AcciMap diagram created during the investigation and shown below. The occurrence is depicted as a chain of events along the bottom of the diagram. Contributing factors at various levels can be examined by moving up and down the diagram.
