## Amateur-built Aircraft Accident in Tikkakoski on April 17, 2022

L2022-02

Investigation designator: L2022-02  
Investigation report 5/2023  
ISBN: 978-951-836-649-5 (PDF)

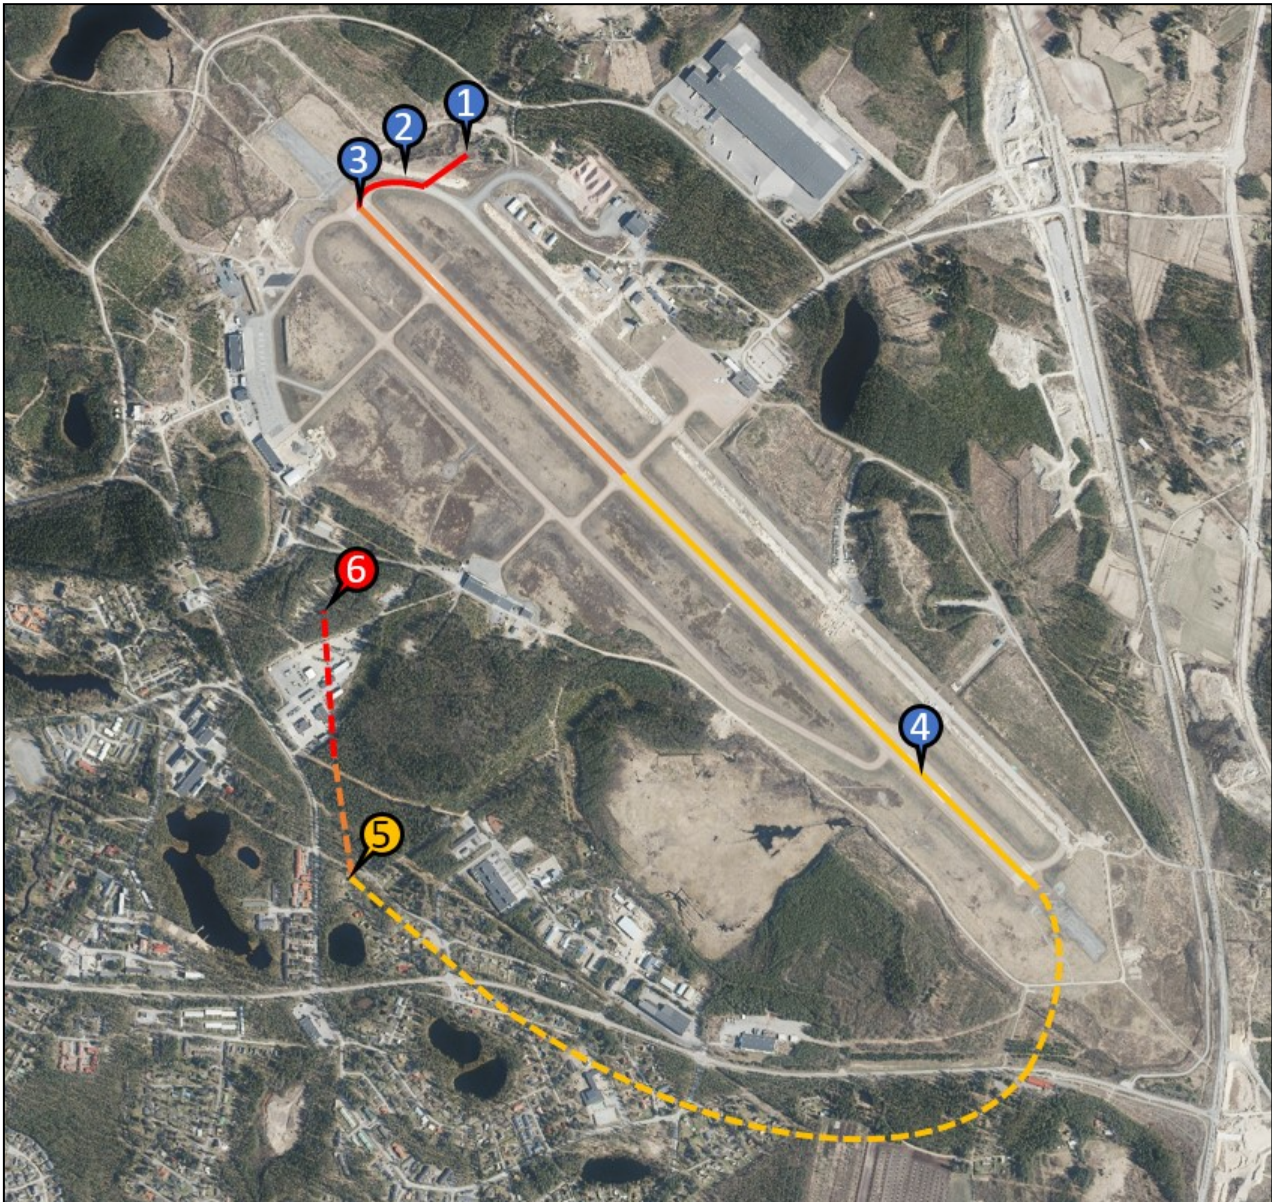
**Figure 1.** The estimated flight track of OH-XMA. **Key:** 1. Initial radio call at 1919 h. 2. Reports at holding point A at 1922 h. 3. Reports takeoff from runway 12 at 1924 h. 4. Reports right turn at 1925 h, estimated position. 5. Engine cuts out, estimated position. 6. Accident site. (Photo: Orthoimage ©National Land Survey of Finland 2/2023, annotated by SIAF)

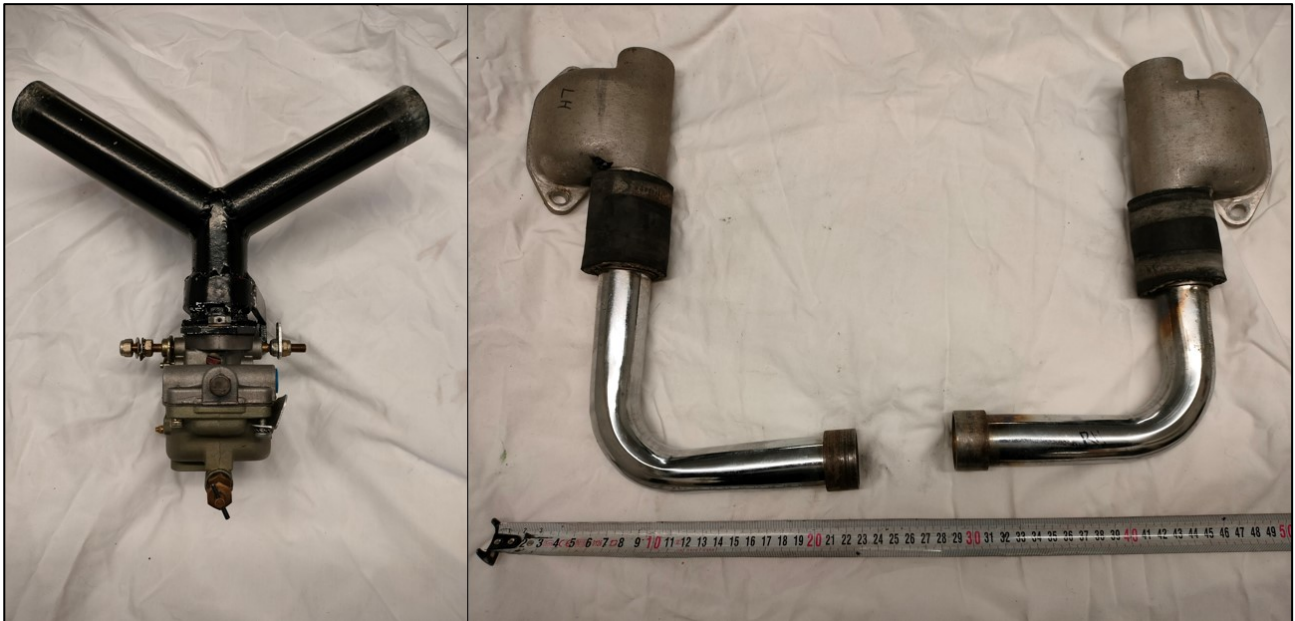
**Figure 3.** On the left: the carburetor and the Y-junction of the inlet ducting. On the right: inlet ducts leading to the cylinder heads. (Photo: SIAF)

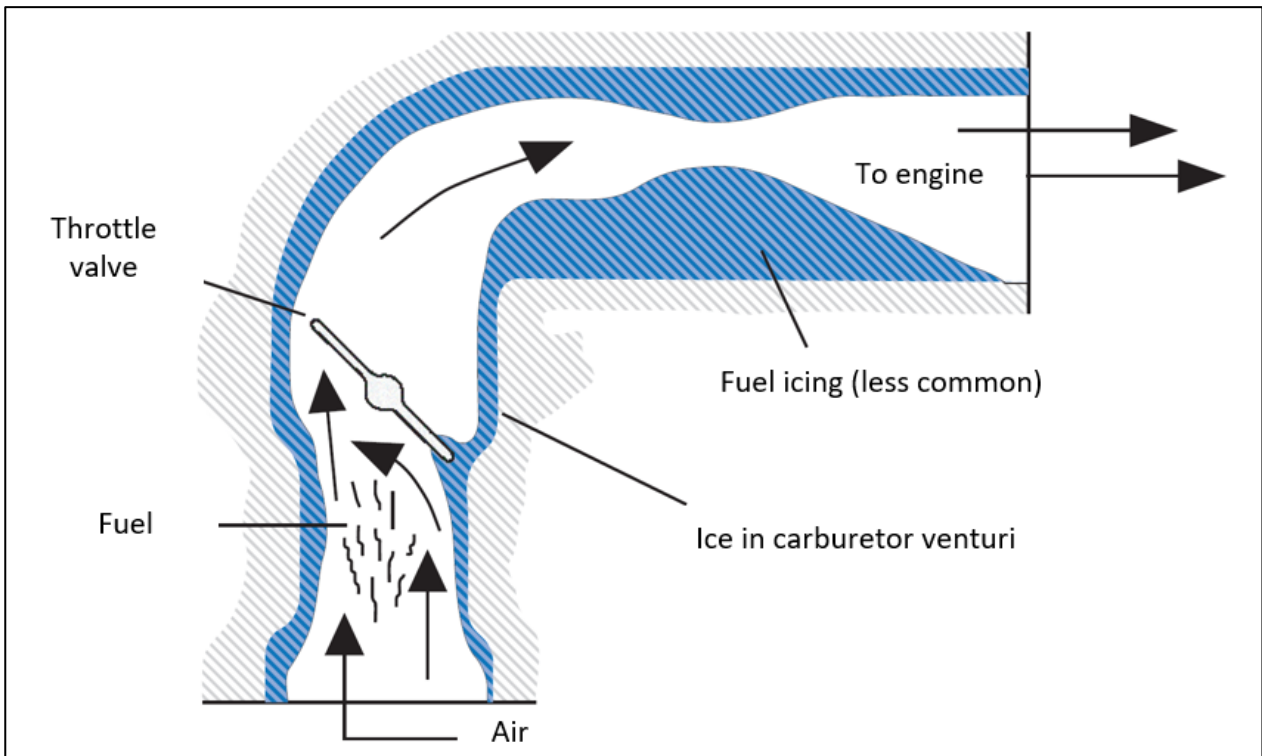
**Figure 13.** Ice build-up in the induction system with ice accumulation shaded in blue. (Photo: EGAST GA5, *Piston Engine Icing*, annotations: SIAF)

In carbureted engines ice forms typically in the engine air filter, induction system bends, the alternate air door, the carburetor venturi and the jet housing, and the throttle valve.
