Apartment fire causing the death of five people in Vantaa on 8 October 2023

Y2023-02

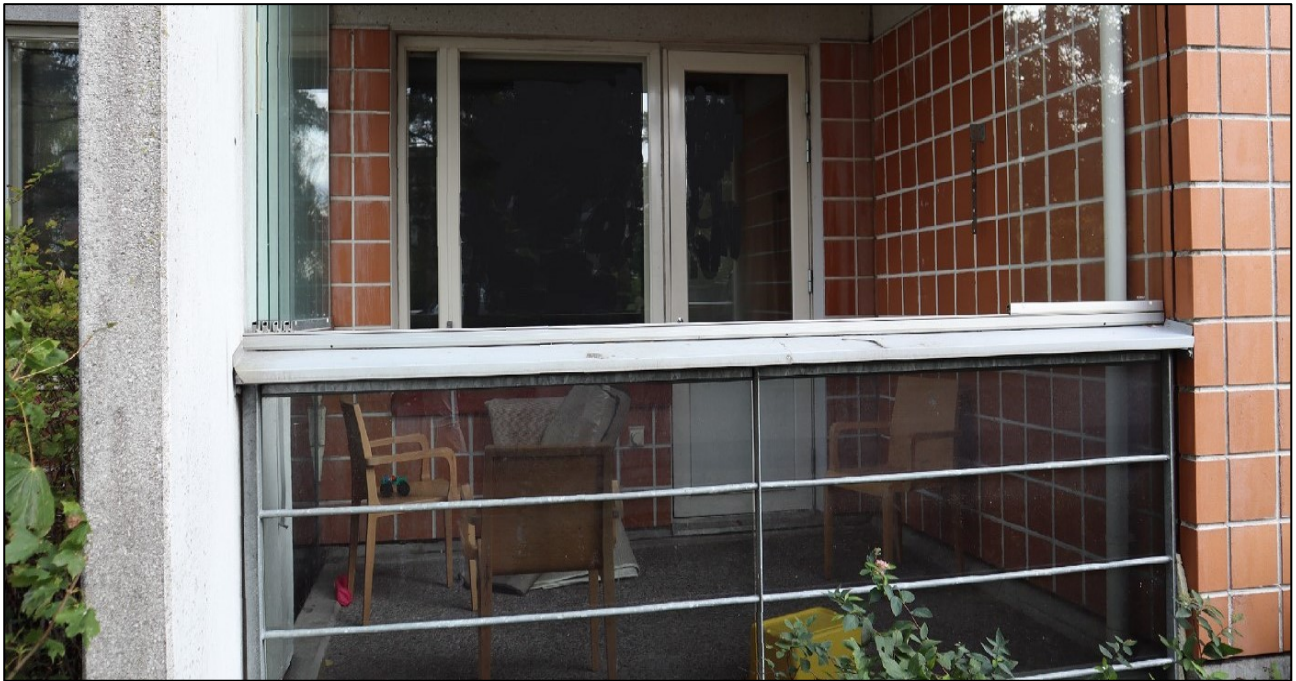
Figure 2. The door leading from the living room to the balcony served as the emergency exit from the apartment. (Photo: Safety Investigation Authority, Finland)

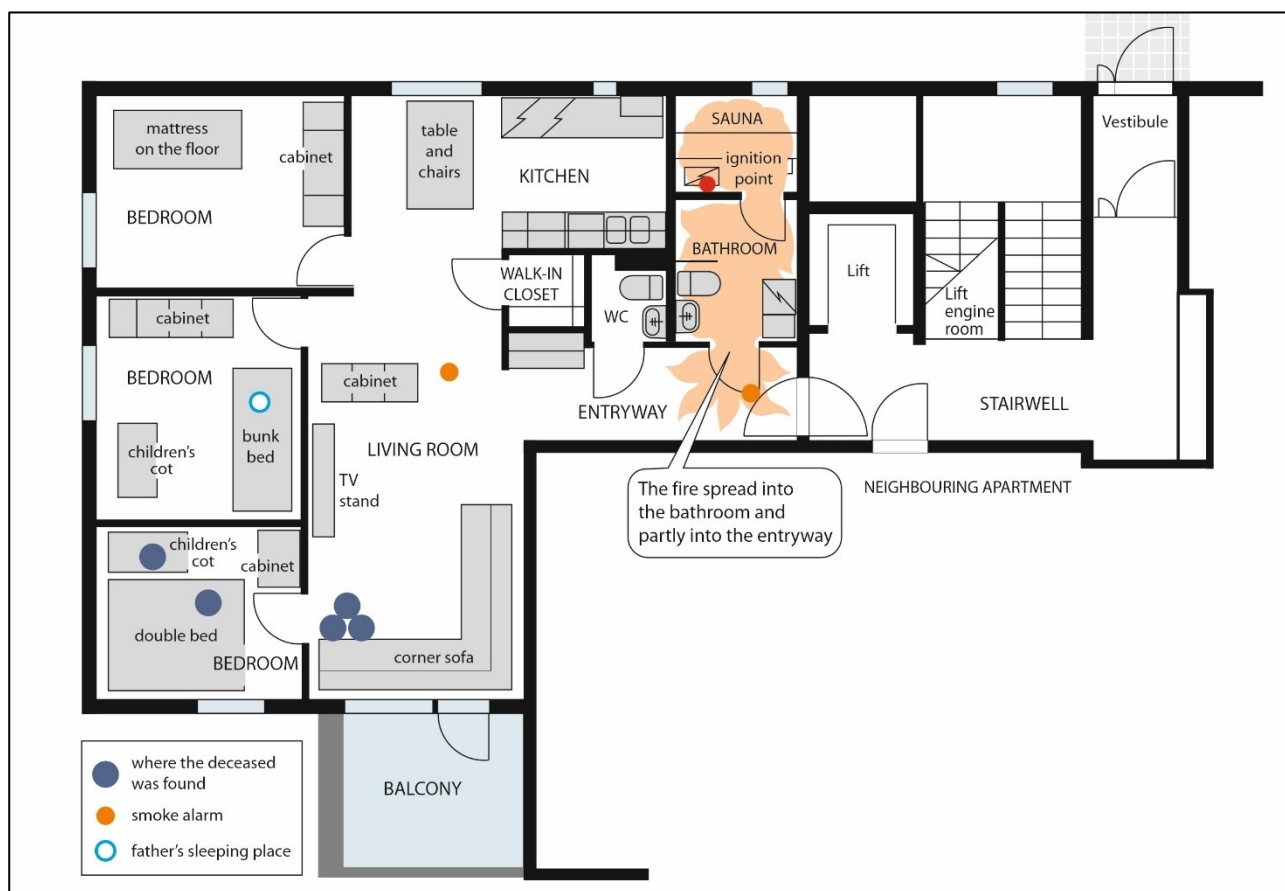
Figure 3. The floor plan of the apartment. (Image: Safety Investigation Authority, Finland)

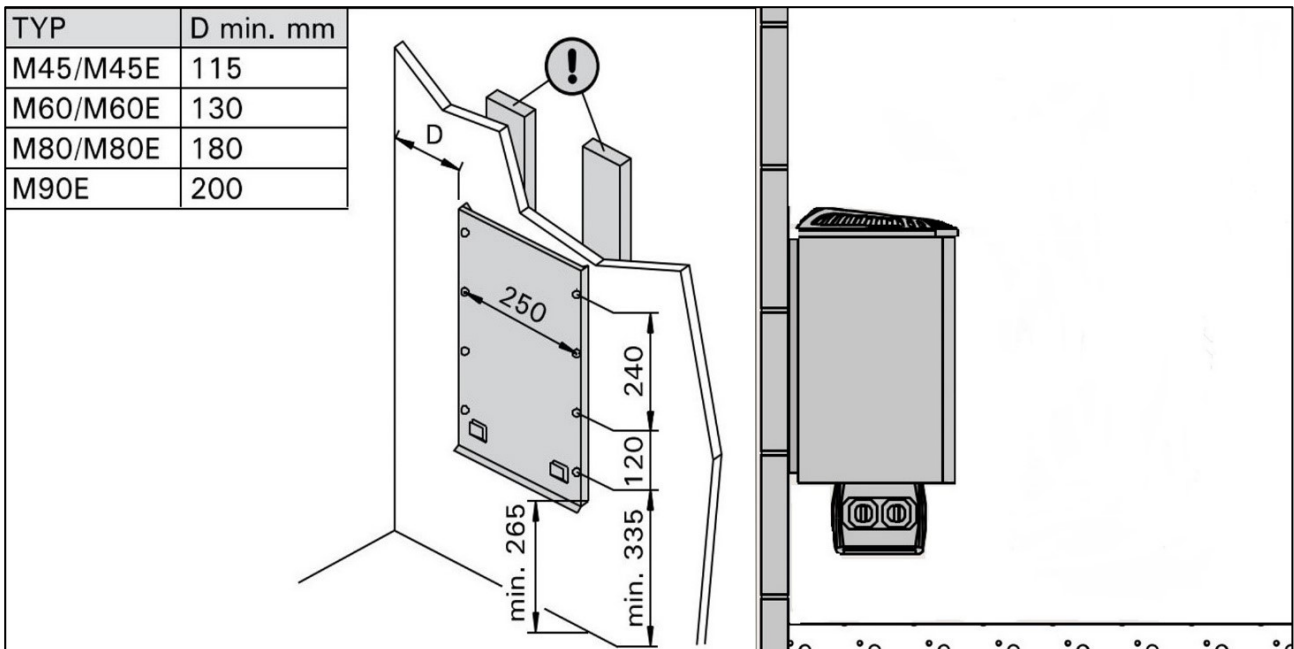
Figure 5. The image shows the installation instructions for the mounting rack on the left and the sauna heater mounted on the wall using the mounting rack on the right. (Images: Harvia)

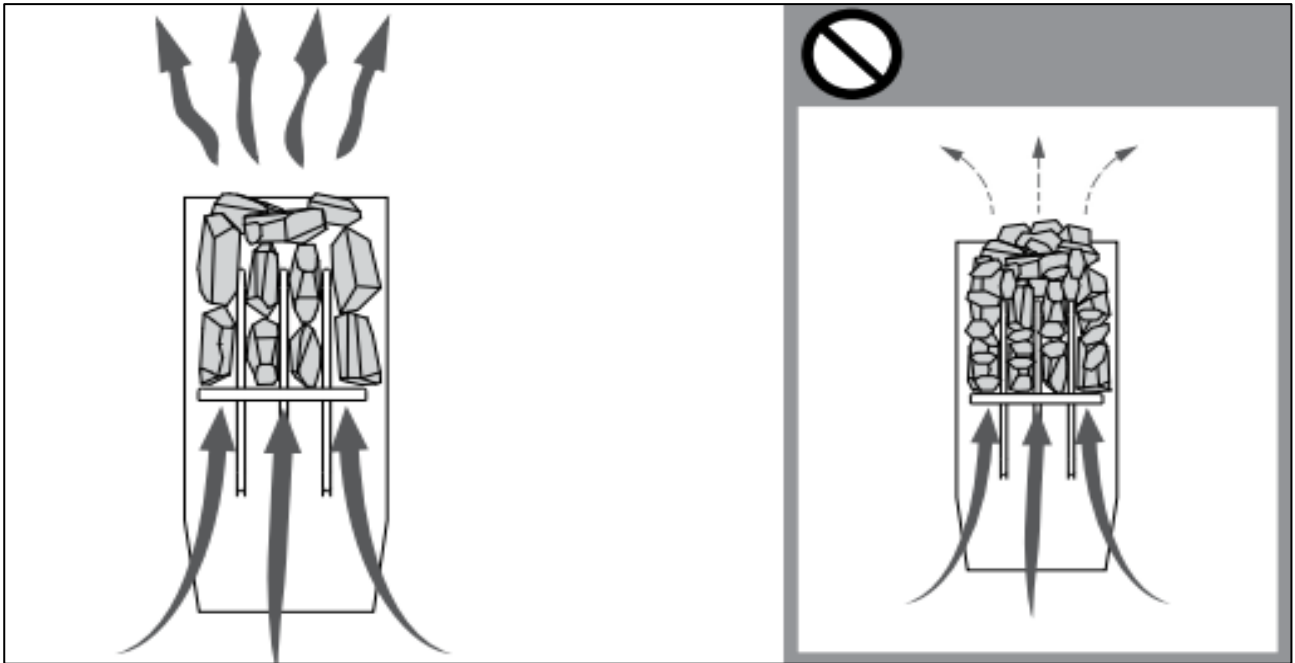
If the sauna stones have been piled too tightly in the heater, the air flow through the stone space will decrease. Less heat will be transferred from the heater to the sauna room with convection than intended. The cooling effect of air flow on the heating elements and stones will decrease and the heating elements will become hotter than normal with the same amount of electrical energy. Increasing amount of heat will start to be transferred from the heating elements by convection and radiation. The stones and the heater structures become hot, and the heater does not reach heat balance until at a higher temperature than before.

Figure 8. According to the user instructions, the stones must not be piled too tightly as this can prevent air from flowing through the heater. (Image: Harvia)

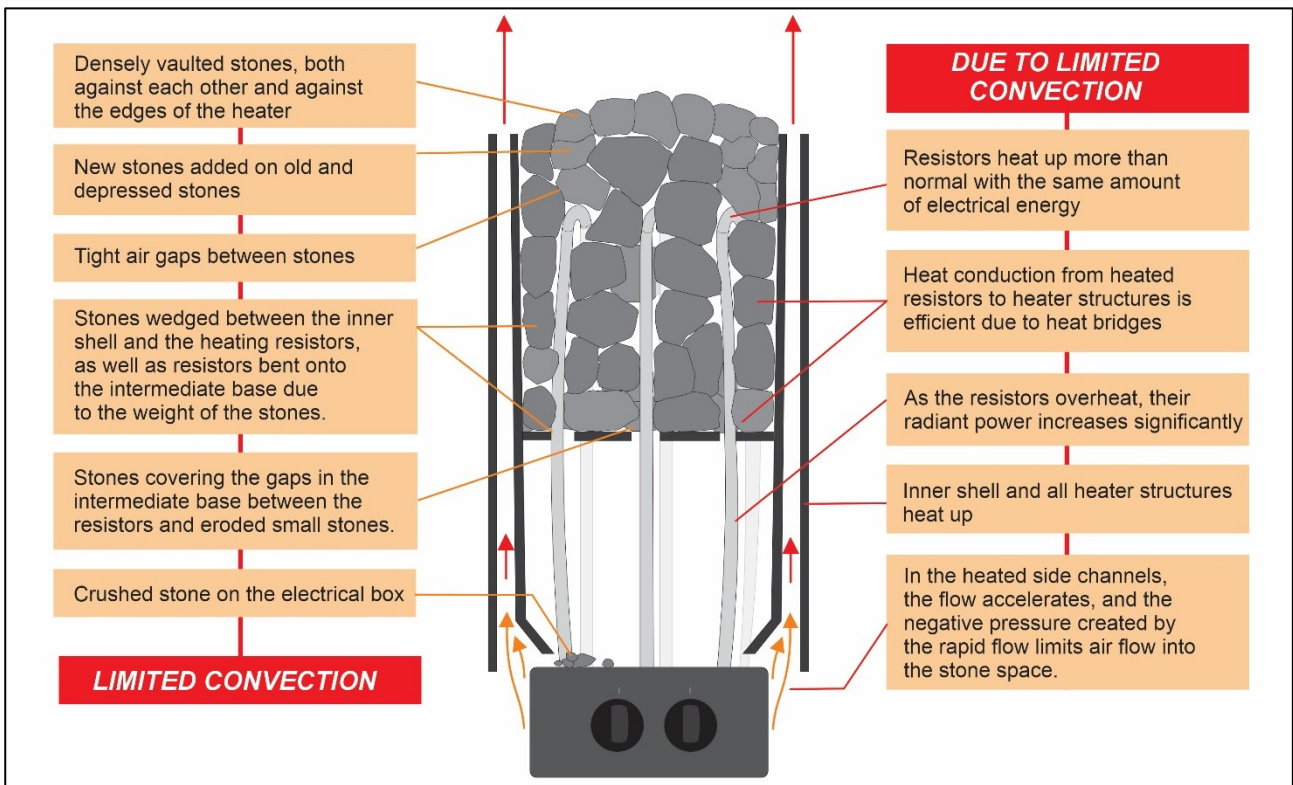
Figure 19. Examples of key factors limiting convection and consequences of limited convection. (Photo: Safety Investigation Authority, Finland)

For the sauna heater to function as a flow-through heater, the air must flow through the stone space by means of free convection. However, convection may be limited if the stones are pressed tightly against one another and against the sides of the heater, or if new stones are added on top of the old, compacted ones. In such a case, narrow air gaps between the stones significantly choke the flow. The stones may also be wrongly placed to begin with, for example, so that stones block the flow openings between the heating elements.
