Separation of Passenger Door on Instructional Flight East of Pori on August 19, 2022

L2022-03

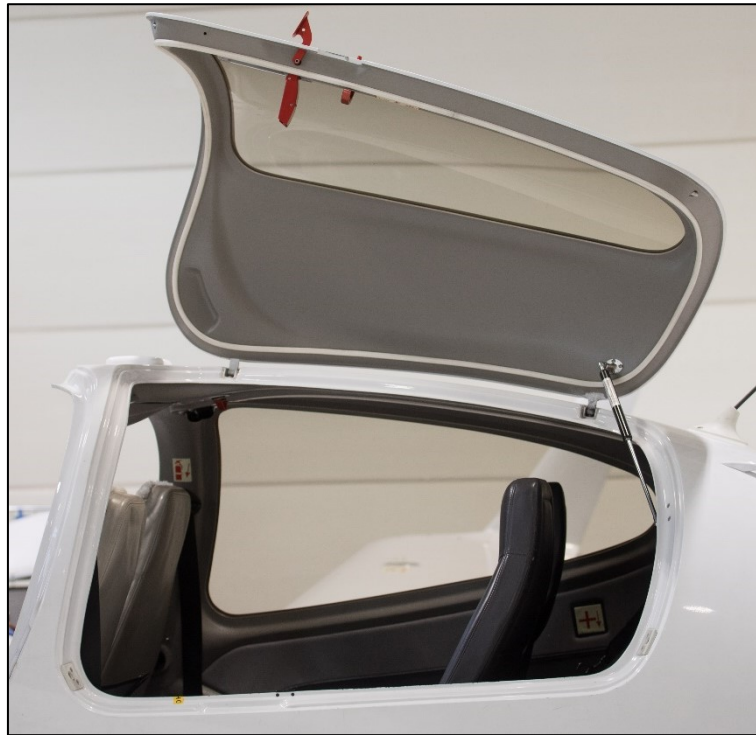
Figure 6. An undamaged passenger door in open position. (Photo: SIAF)

The passenger door, on the left side of the airplane, is attached to the upper fuselage by two hinge assemblies consisting of a hinge bracket and a hinge arm. The hinge brackets are fitted in recesses in the top edge of the door opening, and the composite hinge arms are mounted on the door. A gas pressure damper between the door rear edge and the fuselage prevents the door from dropping during closing, assists in door opening and keeps the door fully open on

the ground. It does not exert an opening force on the door in the fully down position, but after the door is slightly raised, it helps door opening. A damper failure will not open the door.
