Incident report

D 1/2000 Y,
shortened version

Bus Fires in Finland during 2000

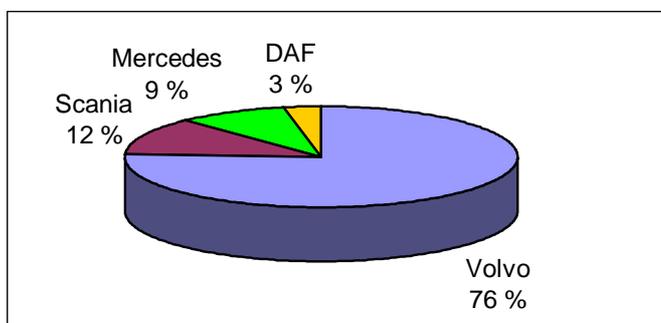
Diagram 1. Distribution of bus fire incidents investigated, by model.

The main reason for the large share of the Volvo model in incidents investigated is the fact that Volvo represents 45% of all buses registered in Finland (according to the 1999 statistics) and 68% of the (low entry) buses used in city traffic (statistics for 2000). Furthermore, of all Volvo buses in city traffic (B10B and B10LA, total 19) there were three recurring causes of fire (a fuel leak, abrasion of the battery cable and overheating of the disc brake) which increased the proportion for this vehicle model. Volvo's share is also possibly increased due to the fact that the importer has its own very comprehensive statistical system. In the statistics there are also small fires in which there is no information available elsewhere; for example from the insurance companies or rescue services. The importer has made statistics available for investigators' use.

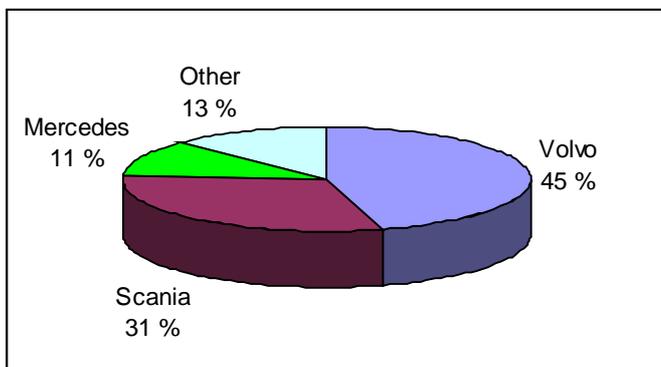
Diagram 2. Distribution of registered buses in 1999, by model.

In 1999 there were about 9 450 buses in Finland of which approximately 4 300 were Volvo, 2 900 Scania and about 1 000 Mercedes.

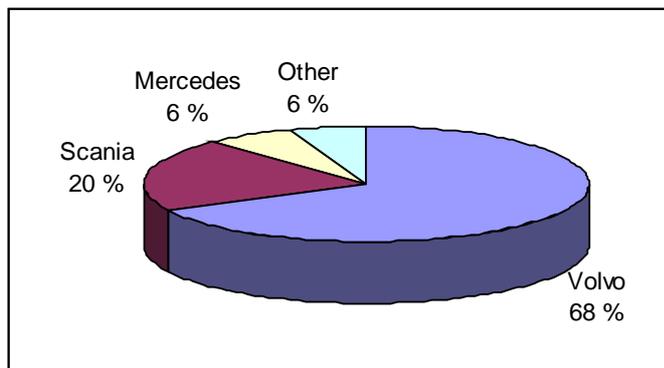
Diagram 3. Distribution of buses (low entry) in city traffic in 2000, by model.

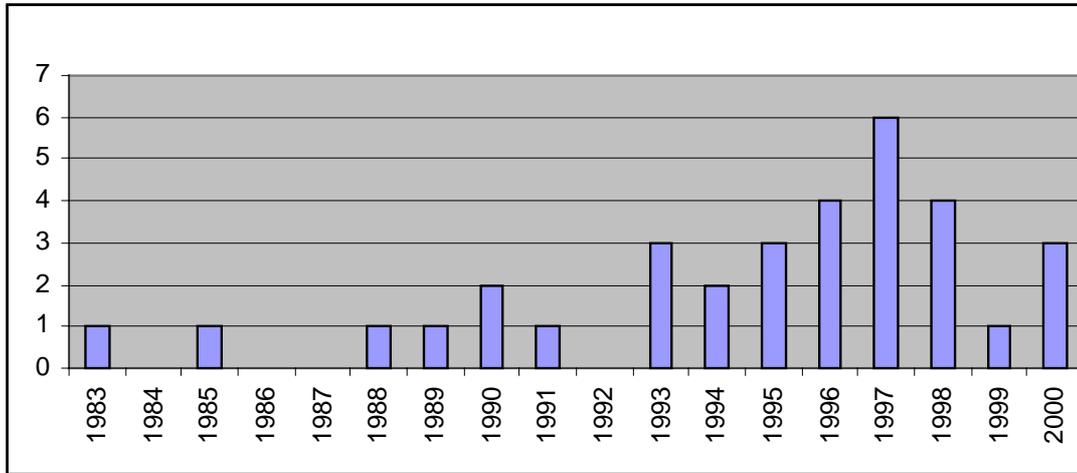
Diagram 4. Bus fire incidents investigated, by year of manufacture.

In the fire statistics the average age of buses is 4.9 years and in 1999 the average age was 11.3 years for buses in Finland. The oldest vehicle that had caught fire was a 1983 model and the most recent a 2000 model. Most fires (6 incidents) took place in 1997 models.

The statistics reveal that the average age of vehicles that have caught fire has been quite low. Vehicles had been driven an average of 430 000 kilometres, ranging from 12 600 to 927 000 kilometres.

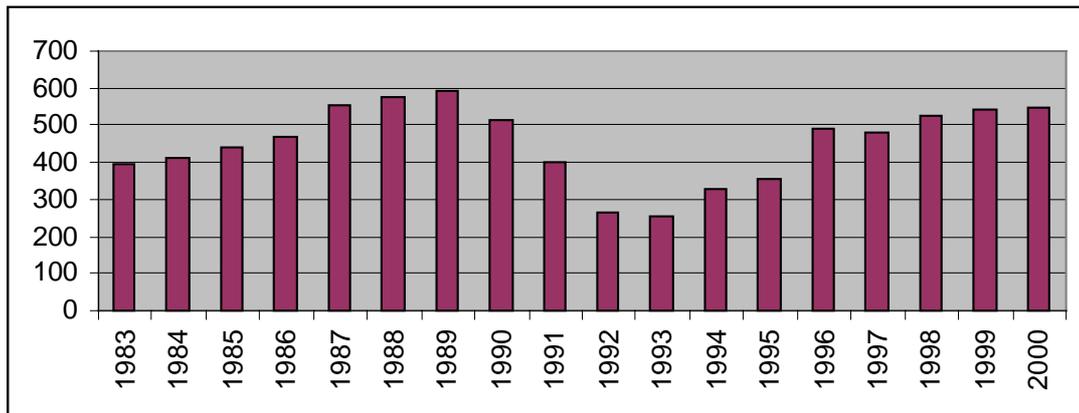
Diagram 5. Number of registered buses between the years 1983 - 2000.

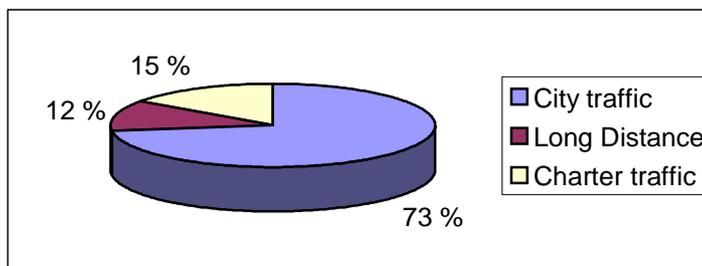
Diagram 6. Forms of traffic.

Clearly the majority of incidents happened in city traffic. This is influenced, among others, by the fact that low entry vehicle types are in use in city service, in which the same

causes were repeatedly found (7 fractures of the fuel pipe, 6 disc brakes jamming and 3 cases of abrasion of the battery cable). Furthermore, one can conclude from the passenger numbers that there is more traffic in cities and that there are a large number of vehicles. A total of 71% of passengers travel in city traffic (the statistics of the Bus Federation (Linja-autoliitto) from 1997 to 1999).

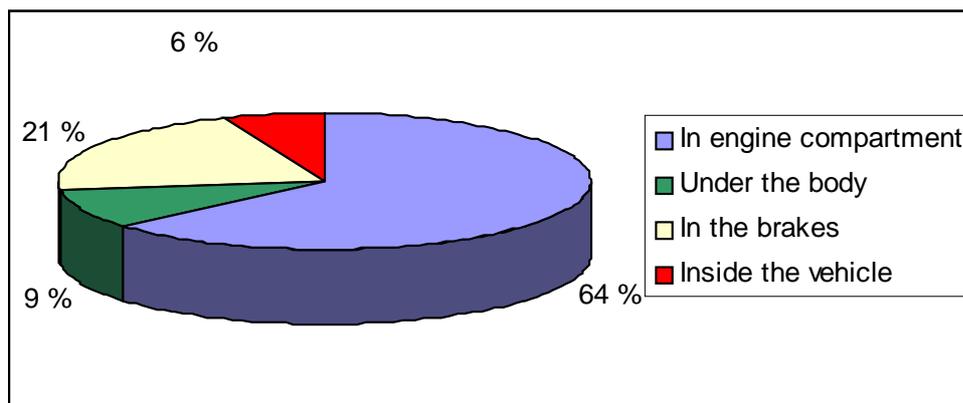
Diagram 7. Origins of the fire.

Fires can be divided into two main types with regard to how they spread: the fire was restricted to the exterior of the passenger compartment, and fires, which spread into the passenger compartment from outside. Only two fires started inside the passenger compartment (cases 1.7 and 1.27).

A total of 31 fires started outside the passenger compartment, 21 of which started in the engine compartment, 7 in the brakes and 3 from under the body.

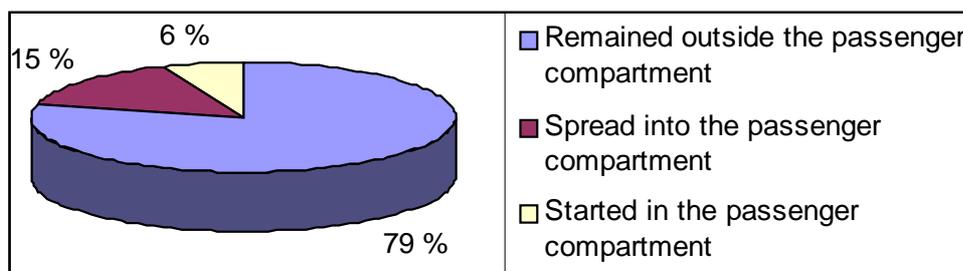
Diagram 8. Spreading of the fire.

Five of the fires that started outside the passenger compartment spread to the passenger compartment. Two of the vehicles were destroyed beyond repair, two were badly damaged and one was slightly damaged. Furthermore, one of the vehicles in which the fire started in the passenger compartment was destroyed.

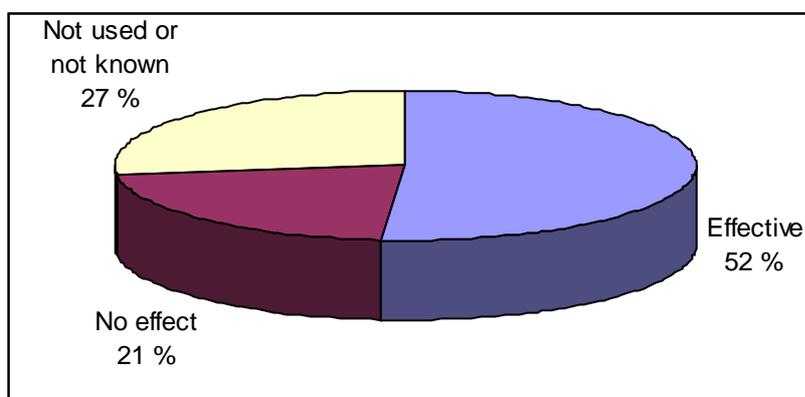
Diagram 9. First-hand extinguishing.

First-hand extinguishing is defined in this context as the actions taken to extinguish a fire before the units of the rescue service arrived at the scene. Of the 33 registered incidents it is known that the driver operated the fire-extinguisher in 23 of them. In three incidents more than one dry powder extinguisher was used. In four incidents the driver obtained help with first-hand extinguishing from other motorists. In one incident water was used to extinguish the fire. In four incidents an extinguisher was not used. There is no information available about fire extinguishing in five cases.

First-hand extinguishing succeeded in 17 incidents. The most common reason for failure was the premature discharge of the extinguisher's contents, i.e. the extinguisher's capacity was too small.

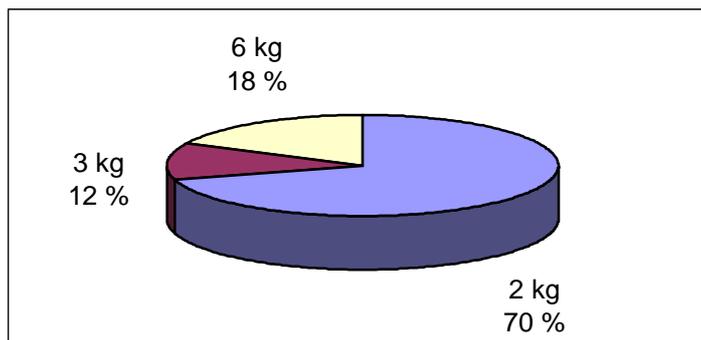
Diagram 10. The size of the fire extinguisher installed in vehicles, by incident.

In buses a dry powder extinguisher with at least a 2 kg capacity is required; this has proved to be too small in many extinguishing situations, i.e. the extinguisher contents were exhausted before the fire was put out, or the fire re-ignited again when the extinguisher had discharged its contents. Only in four incidents was a 6 kg extinguisher available.

In those incidents about which the size of the fire extinguisher is known there were 15 instances of a 2 or 3 kg dry powder extinguisher, and 4 instances of a 6 kg extinguisher. A 2 or 3 kg extinguisher was often found to be inadequate. It is thus justifiable to propose that every vehicle should be equipped with at least a 6 kg fire extinguisher.

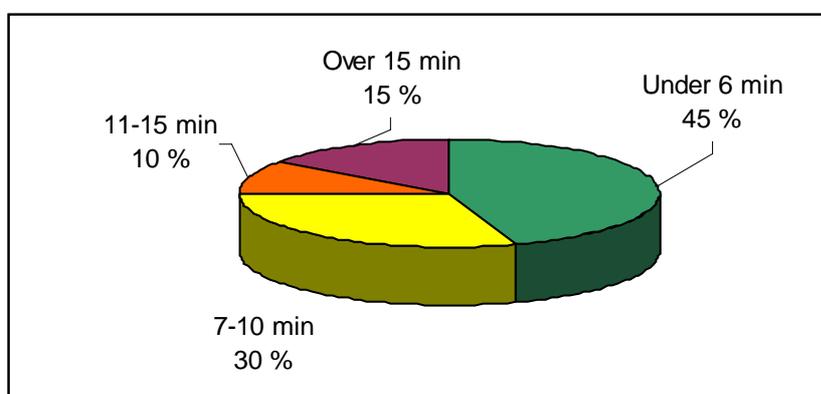
Diagram 11. Arrival time of the fire fighters.

In 21 out of 28 incidents where fire extinguishing information was available fire fighters were asked to attend. The average time of arrival was 11 minutes, the longest individual time being about 50 minutes (from Inari to Kaamanen in Lapland; about 60 km). In the Helsinki metropolitan area the time taken to arrive at the scene was on average six minutes. In rural areas the length of time to arrive ranged from 15 to 50 minutes. In ten incidents only the securing and cooling of the extinguished fire remained the task of the fire fighters.

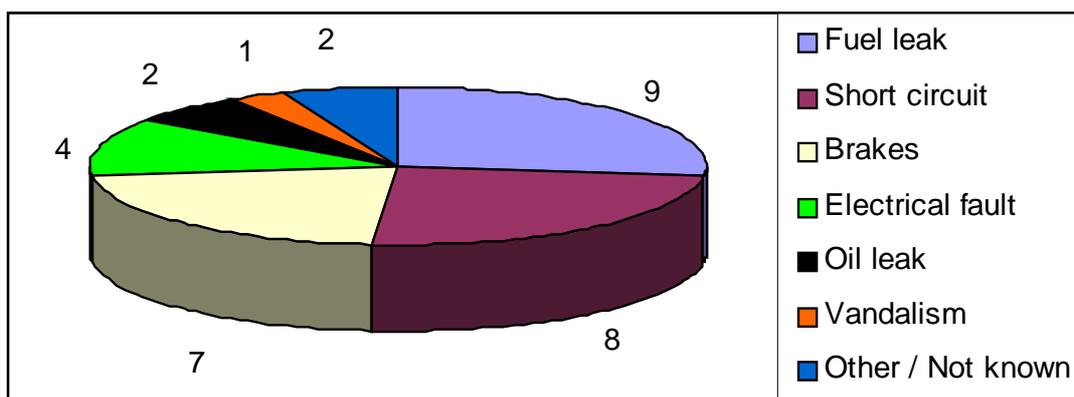
Diagram 12. Causes of the fires.

The causes of the fires can be roughly divided into four categories: fuel leaks (28%), short circuits (24%), brake fires (21%) and other causes (27%).
