## Summary of Investigation

**Collision between the tug Vega and the mv Harriett during a towing operation when entering the Mussalo basin in Port Kotka on 05.04.2009, resulting in the damage of the azipod of the Vega**

Tallinn

30.06.2009

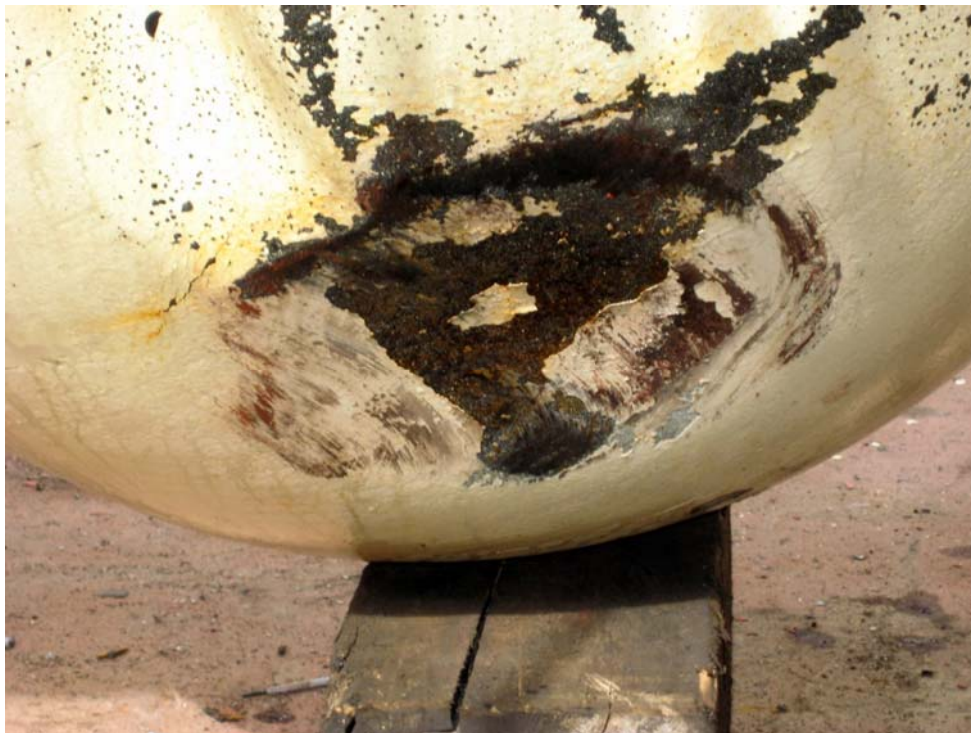
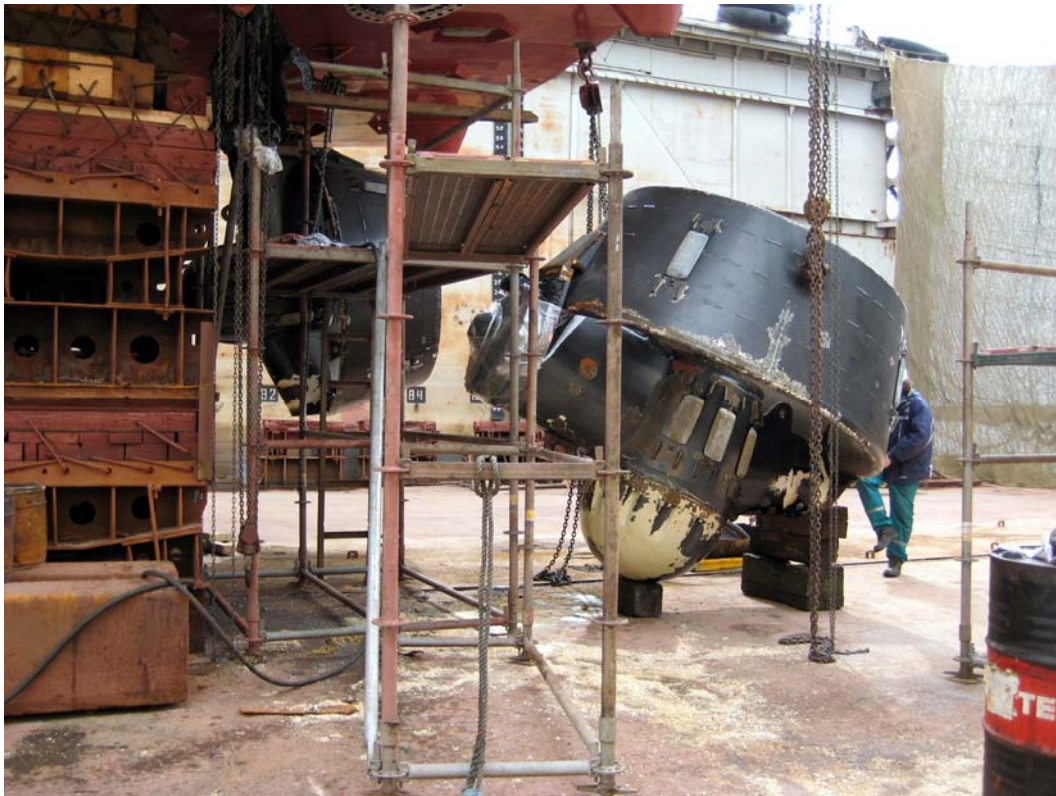
The contact between the lower fairing of the port side azipod of the Vega and the bow bulb of the Harriett was caused by an error, committed by the master of the Vega, who failed to keep the tug on the course that had been given from the bridge of the Harriett. The Vega strayed to the left in relation to the bow of the Harriett, and as a result of the following handling of the azipods, the Vega came into contact with the bow of the Harriett.

No damages of the mv Harriett were discovered, they had no claims to the tug. No claims about the small oilspill in the water area of Port Kotka were launched. A detailed inspection of the port side azipod of the tug Vega was carried out in a floating dock of the Baltic Ship Yard in Tallinn. The management of the PKL made a decision to send the azipod to the manufacturer in Rauma to have it repaired there.
